# Imray Correction Notice ICA301

## Chart **A301** WGS 84

*Edition 2006*

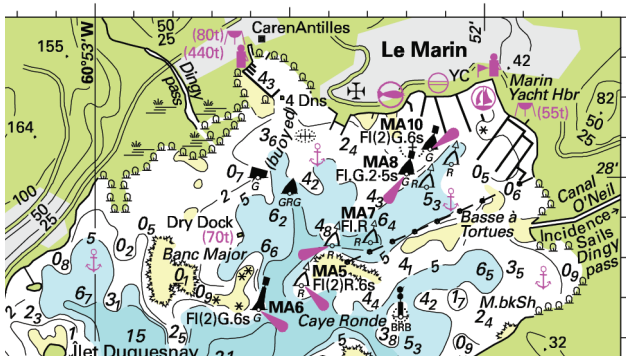
Block correction for A301 (Plan B)  
ILNW 453/18

Insert accompanying block correction centred on 14°27'·99N 60°52'·41W (Doyle/Street 9/2018) (ILNW 453/18)
