Imray Correction Notice ICY9-3

25 July 2024

Chart **Y9** WGS 84 Edition 2018

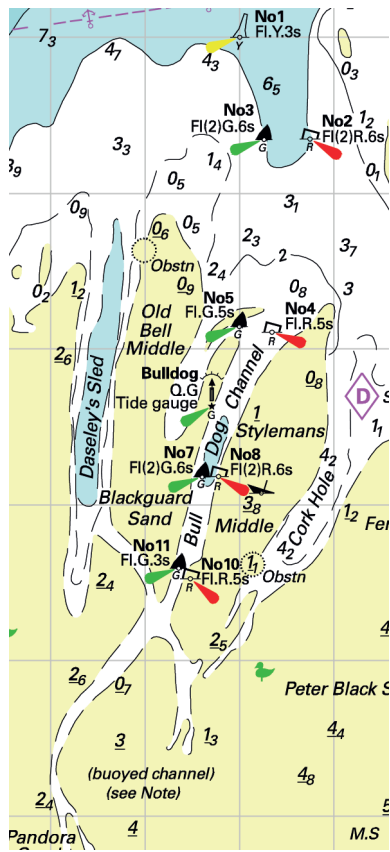
Block correction for Y9
 ILNW 175/22

25 Bull Dog Channel

Insert accompanying block correction centred on 52°53'·49N 0°22'·57E (ILNW 175/22)
