Imray Correction Notice ICA30-2

Chart **A30** WGS 84

Edition 2018

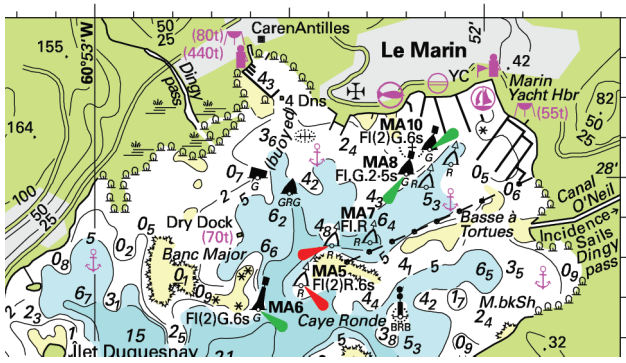
Block correction for A30 (Plan D)
ILNW 452/18

1 **Cul-de-Sac Marin (Plan D)**

Insert accompanying block correction centred on 14°27'·99N 60°52'·41W (Doyle/Street 9/2018) (ILNW 452/18)
